PERATION

GREENHOUSE

SCIENTIFIC DIRECTOR'S REPORT

ANNEX 3.2 U. S. NAVY STRUCTURES

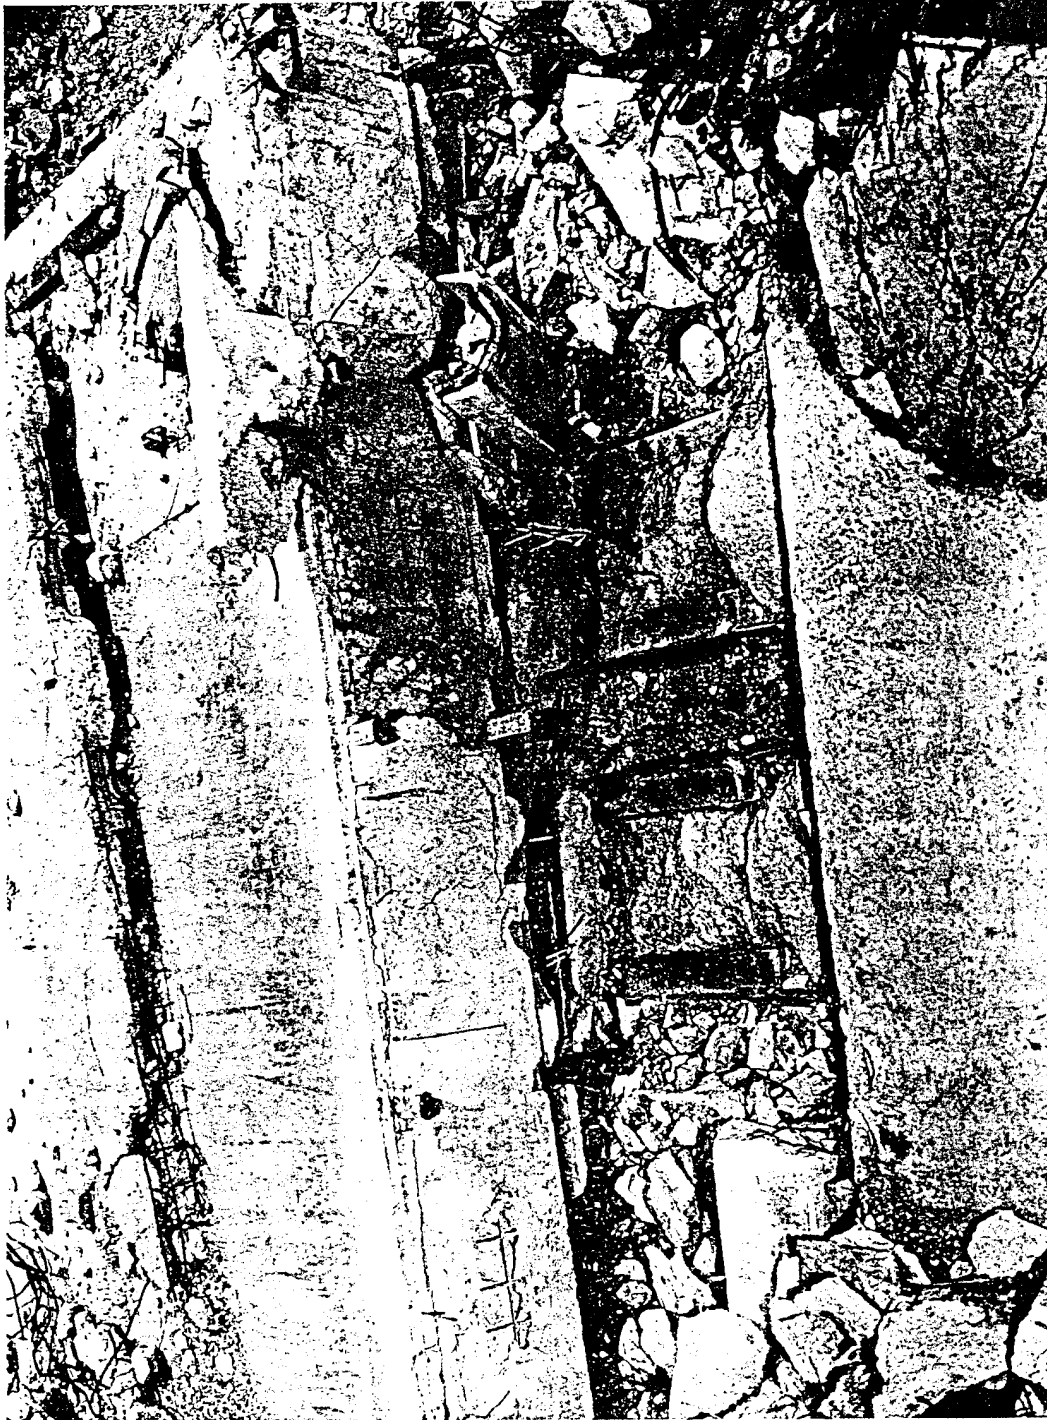
Fig. L.225 Detail View of Anchorage Failures, Structure 3.2.3b. Trusses pulled loose from channels by shearing out the base metal of the channel at the weld location.

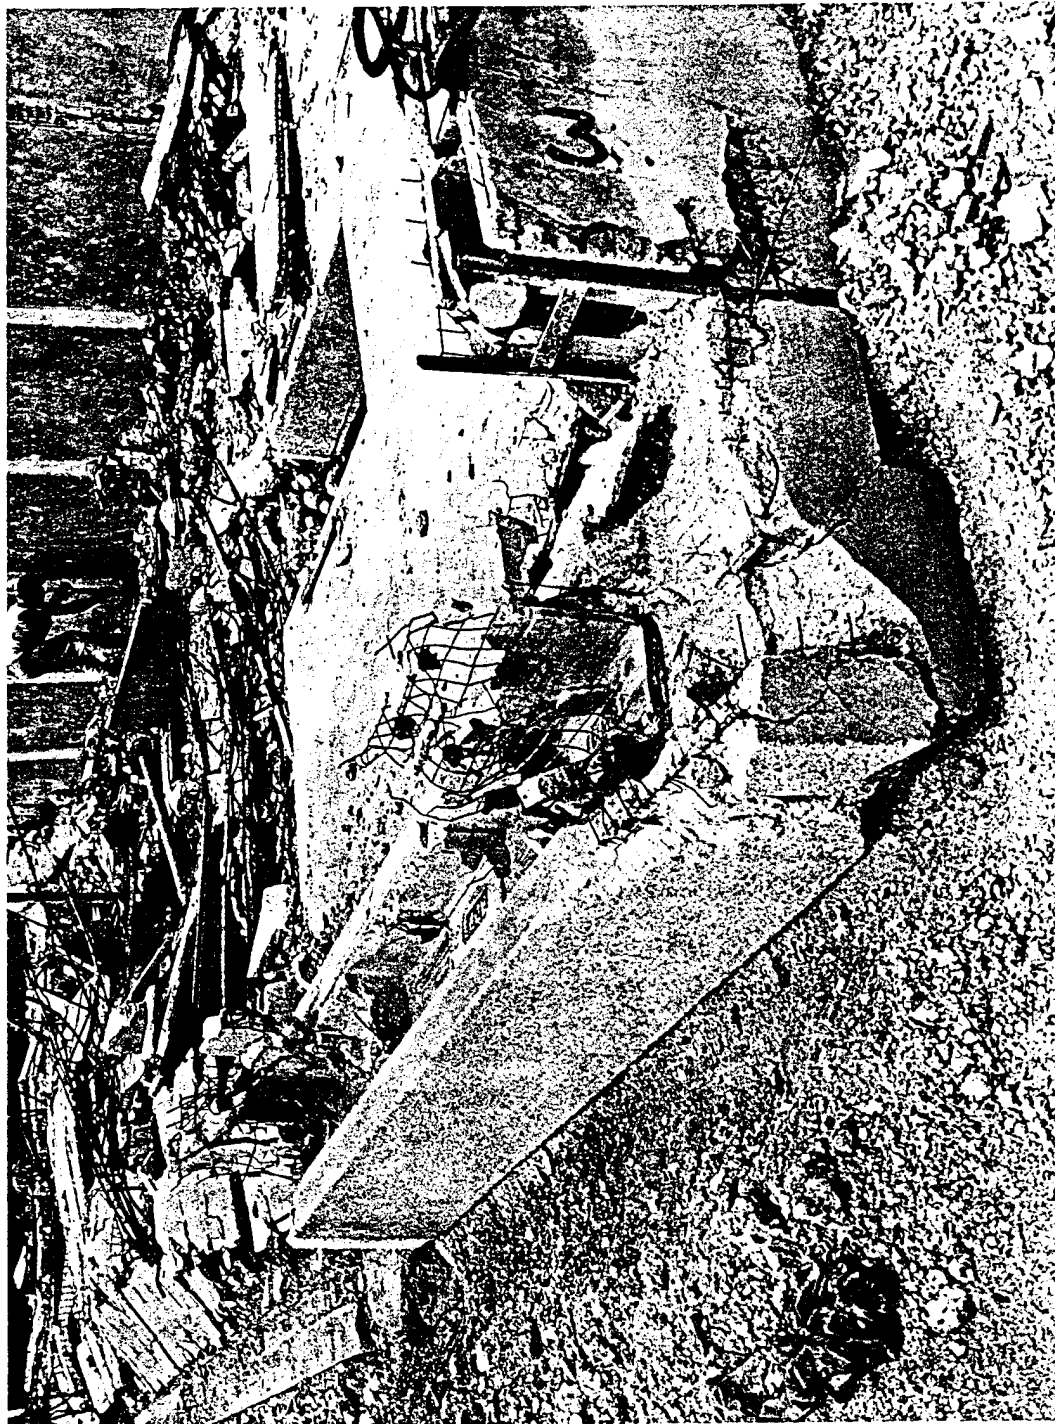
Fig. L.226 Detail View Showing Relative Positions of Anchorage Channels and Rest of End Wall, Structure 3.2.3b.
Note the almost simultaneous pulling up of one channel and failure of weld between truss and channel.

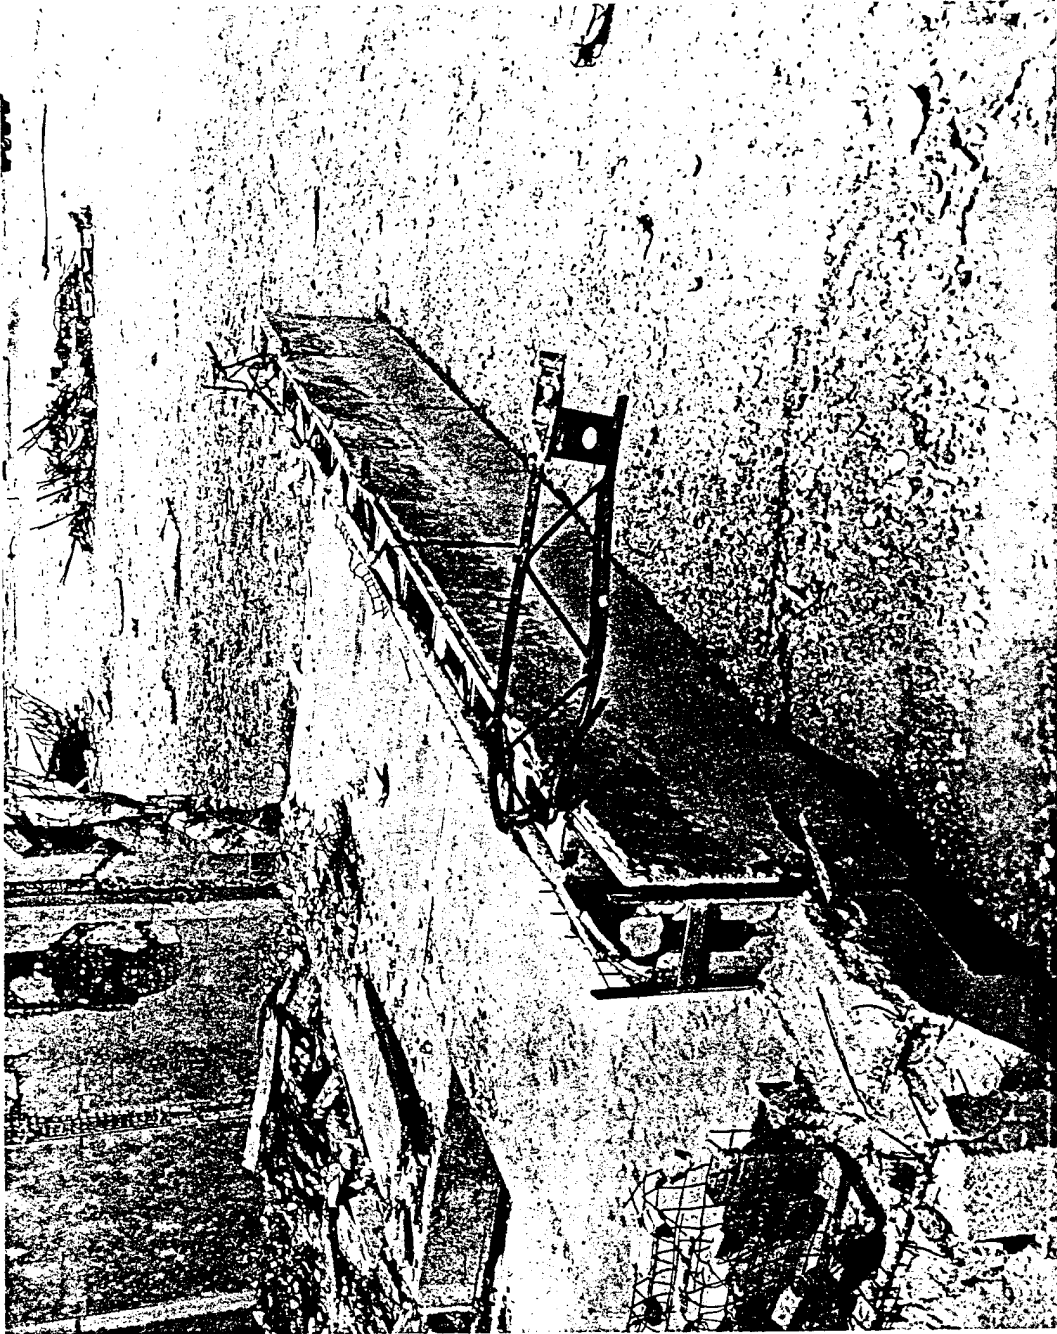
Fig. L.227 Pilaster Corner of Right End Wall, Structure 3.2.3b. Detail view of cell failures at this location is shown.

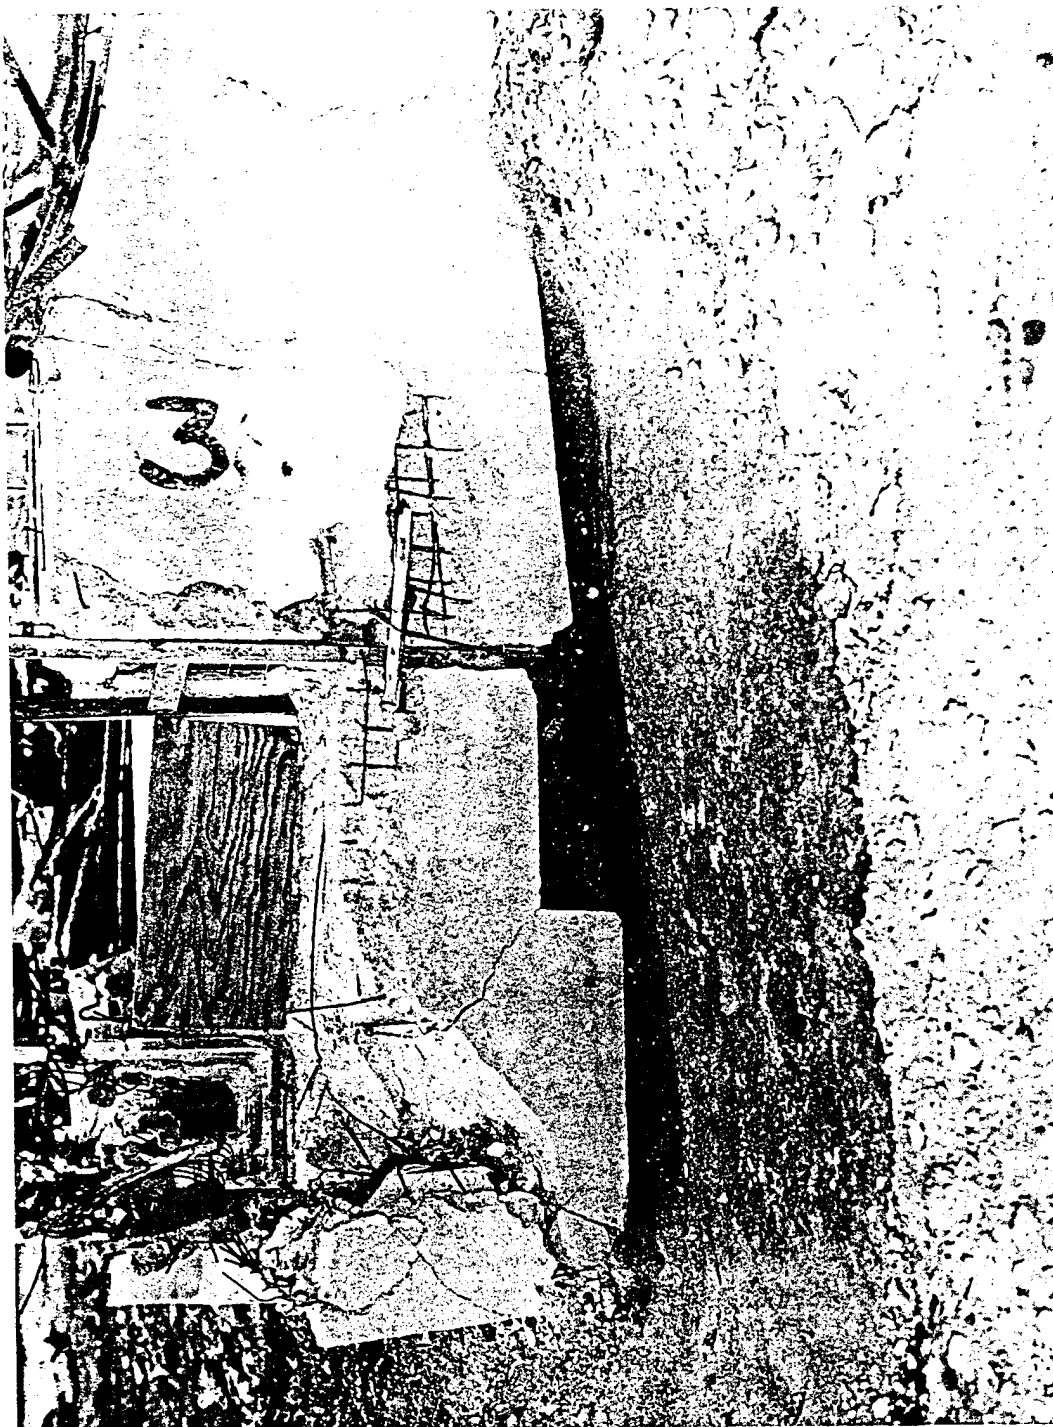
Fig. L.228 View Showing How Edge Row of Roof Cells Remained with End Wall, Structure 3.2.3b. Special transverse trusses between top of end wall and first roof truss caused this row of cells to act as a unit with the end wall. One of the transverse trusses can be seen along face of cell in left foreground.

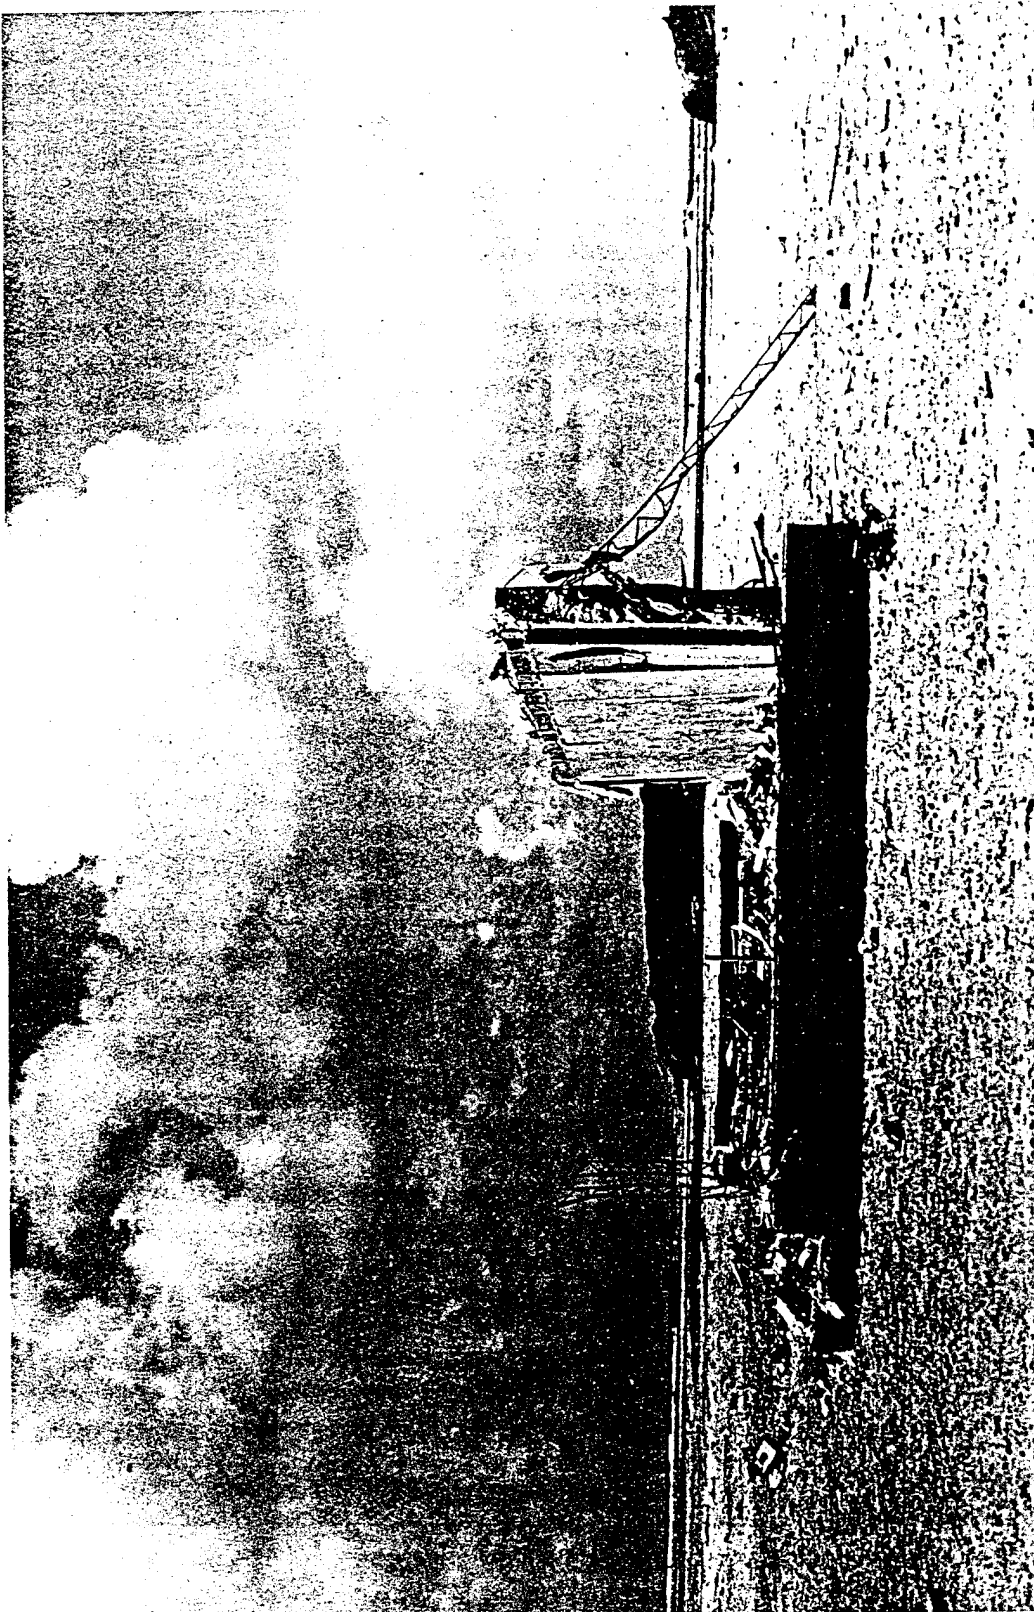
Fig. L.229 Slight Bend at First Cell Line Past Pilaster Corner, Caused by Projection of Pilaster upon Landing, Structure 3.2.3b. One of the transverse trusses mentioned in the preceding caption can be seen in center of this photograph.

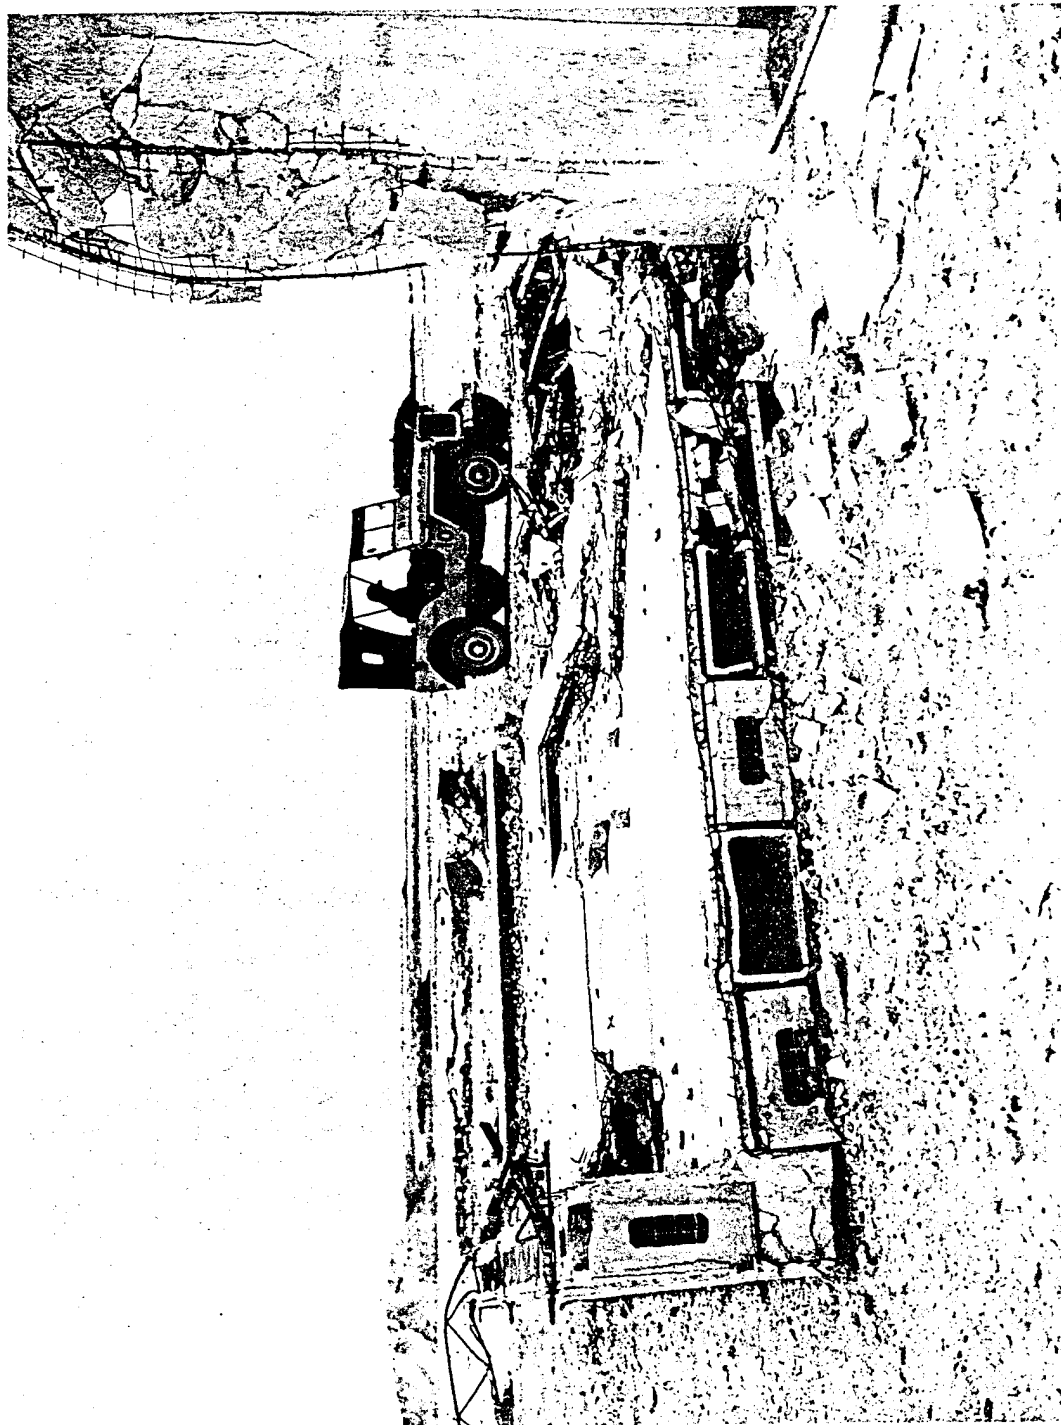
Fig. L.230 Top End of Right End Wall, with Edge Row of Roof Cells Attached and Intact in Foreground, Structure 3.2.3b

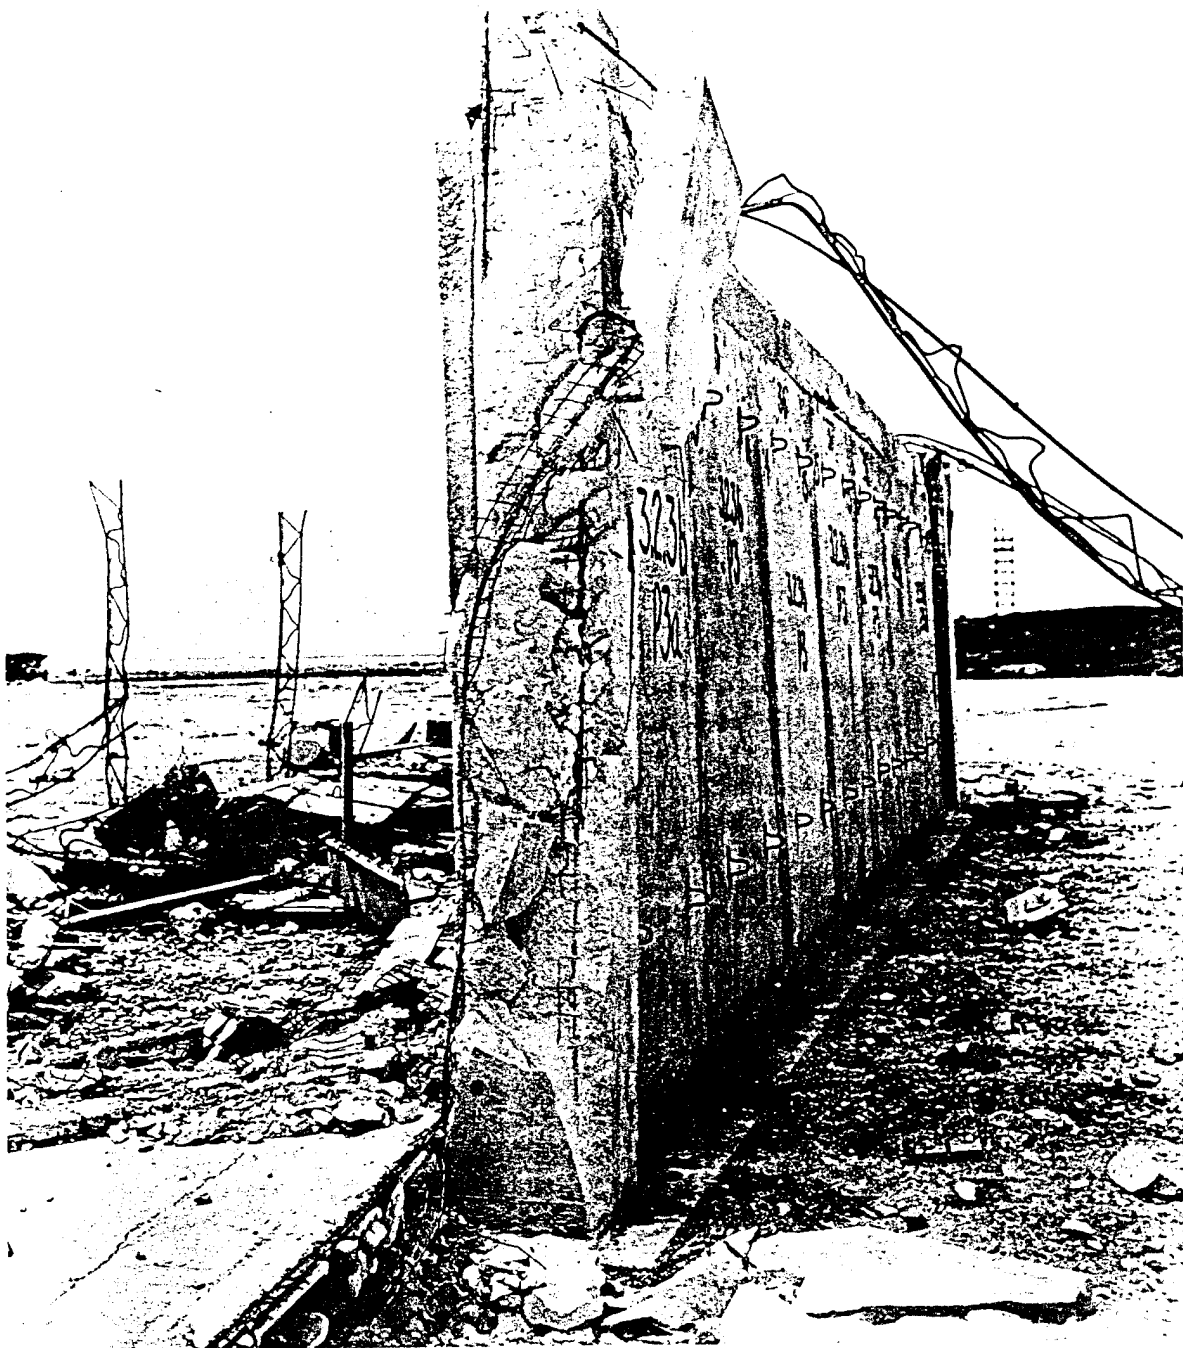
Fig. L.231 Rear Edge of Right End Wall, Structure 3.2.3b. Note that pilaster corner remained with rear wall and the panel shown here sheared out of the pilaster, rupturing the pilaster as the end wall rotated outward.

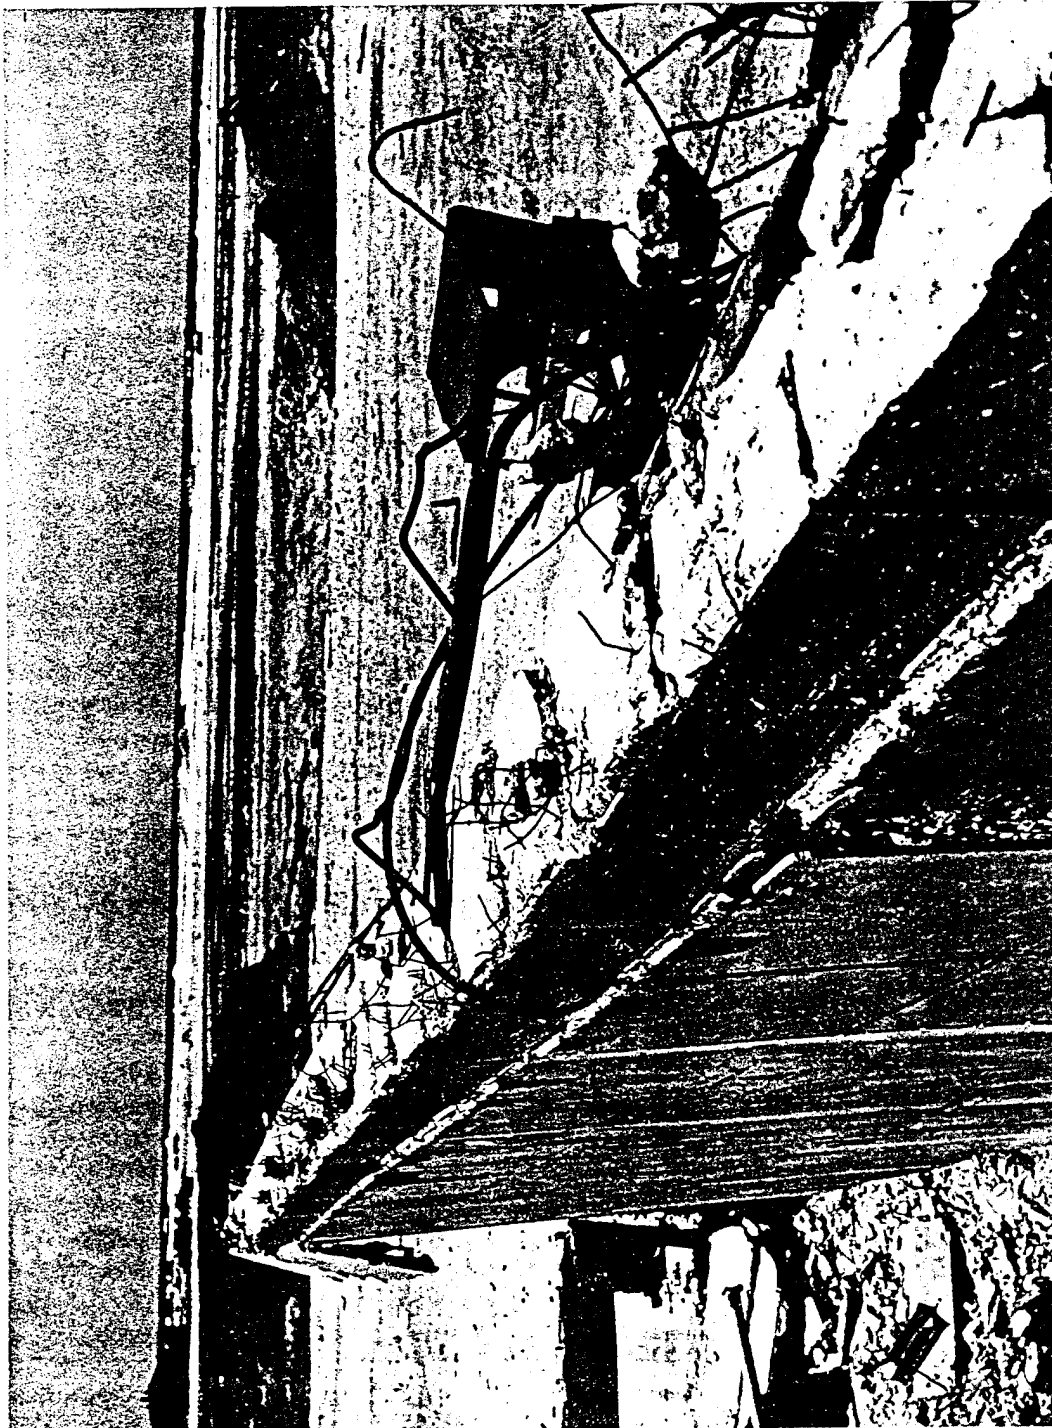
Fig. L.233 View along Top of Rear Wall, Structure 3.2.3b. Little damage was done to the top surface. Extreme bending of roof trusses as roof flipped over can be seen.

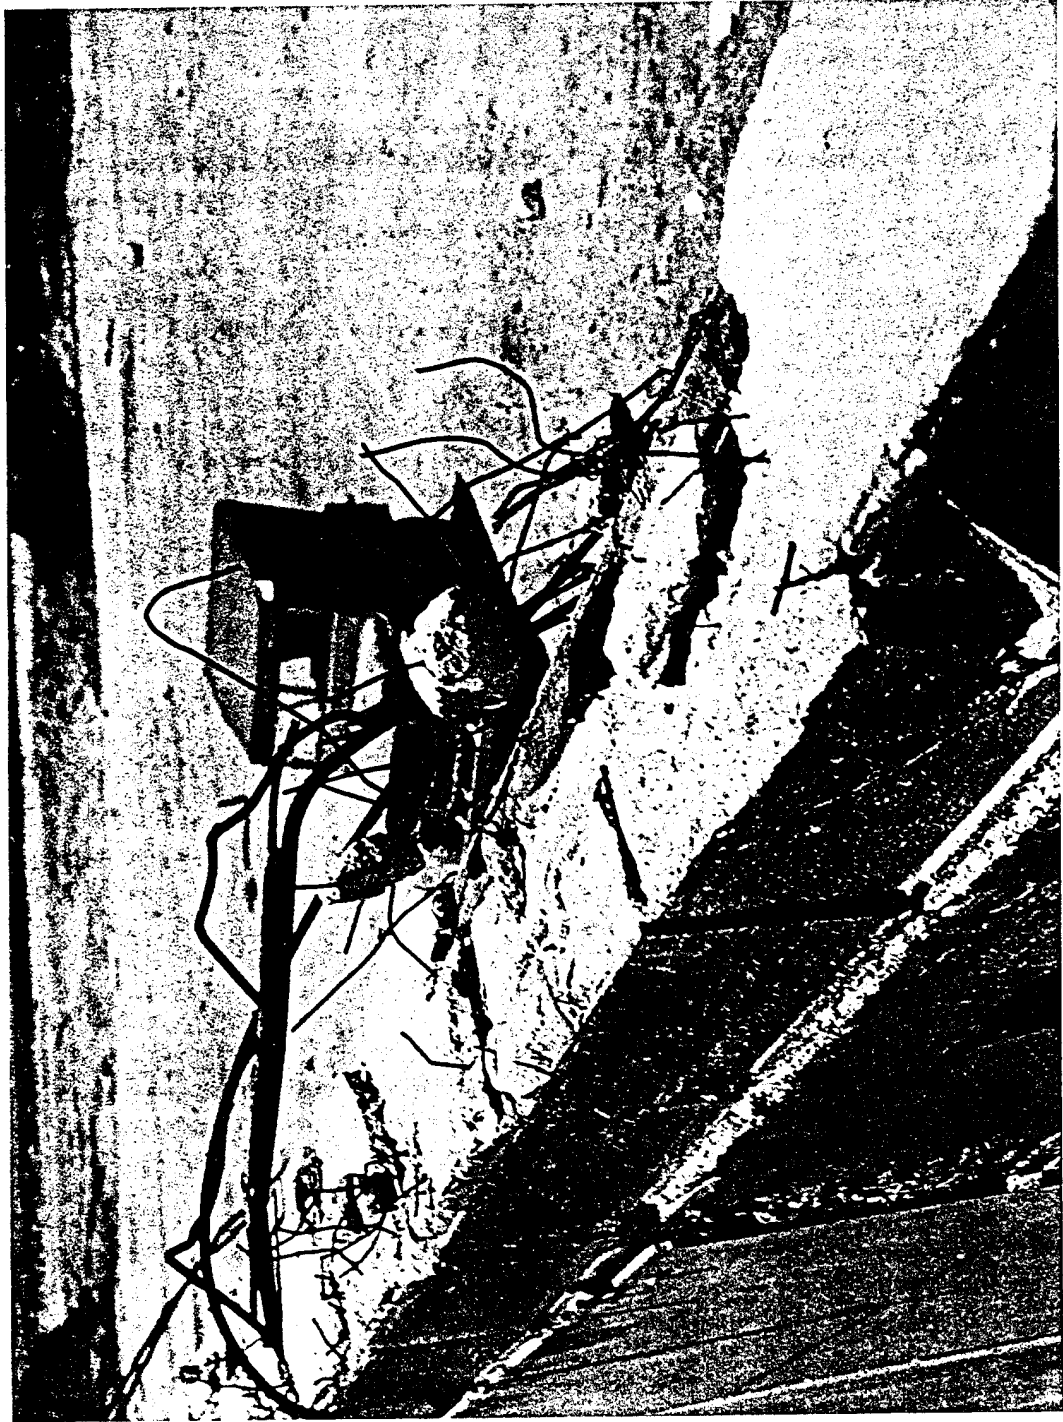
Fig. L.234 Detail of Bent Roof Truss, Structure 3.2.3b. Rest of roof trusses broke loose at weld to end plate and went with roof.

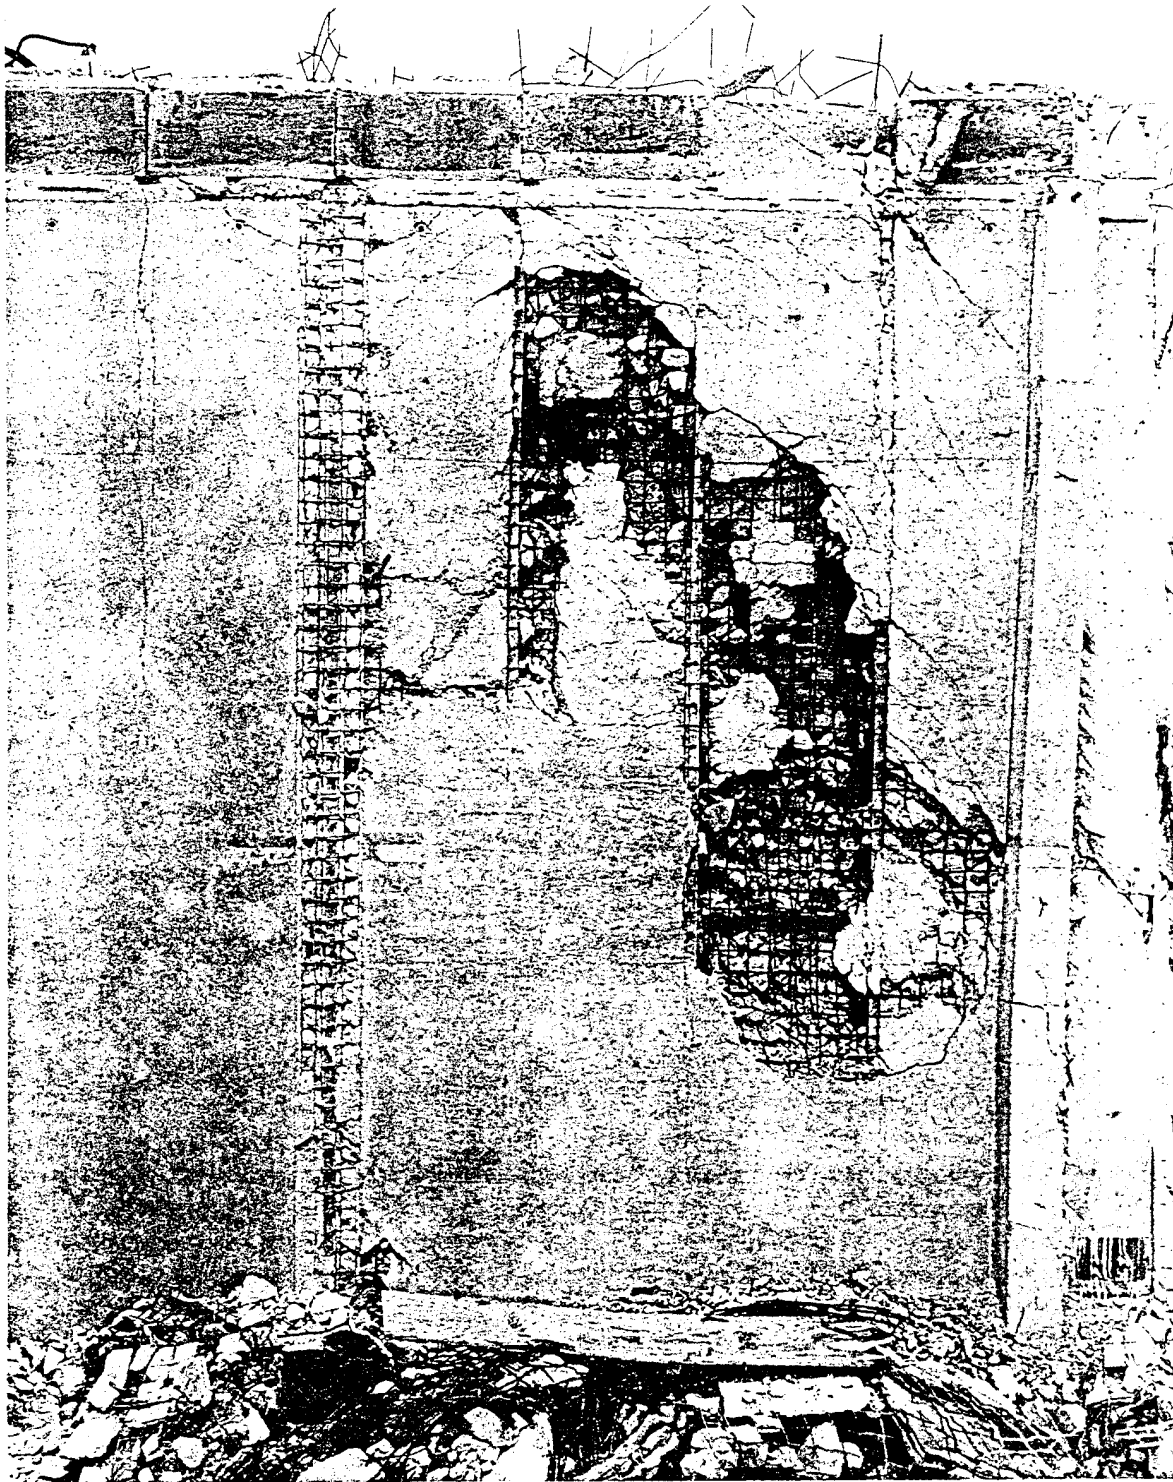
Fig. L.235 Close-up View of Top Edge of Rear Wall, Structure 3.2.3b

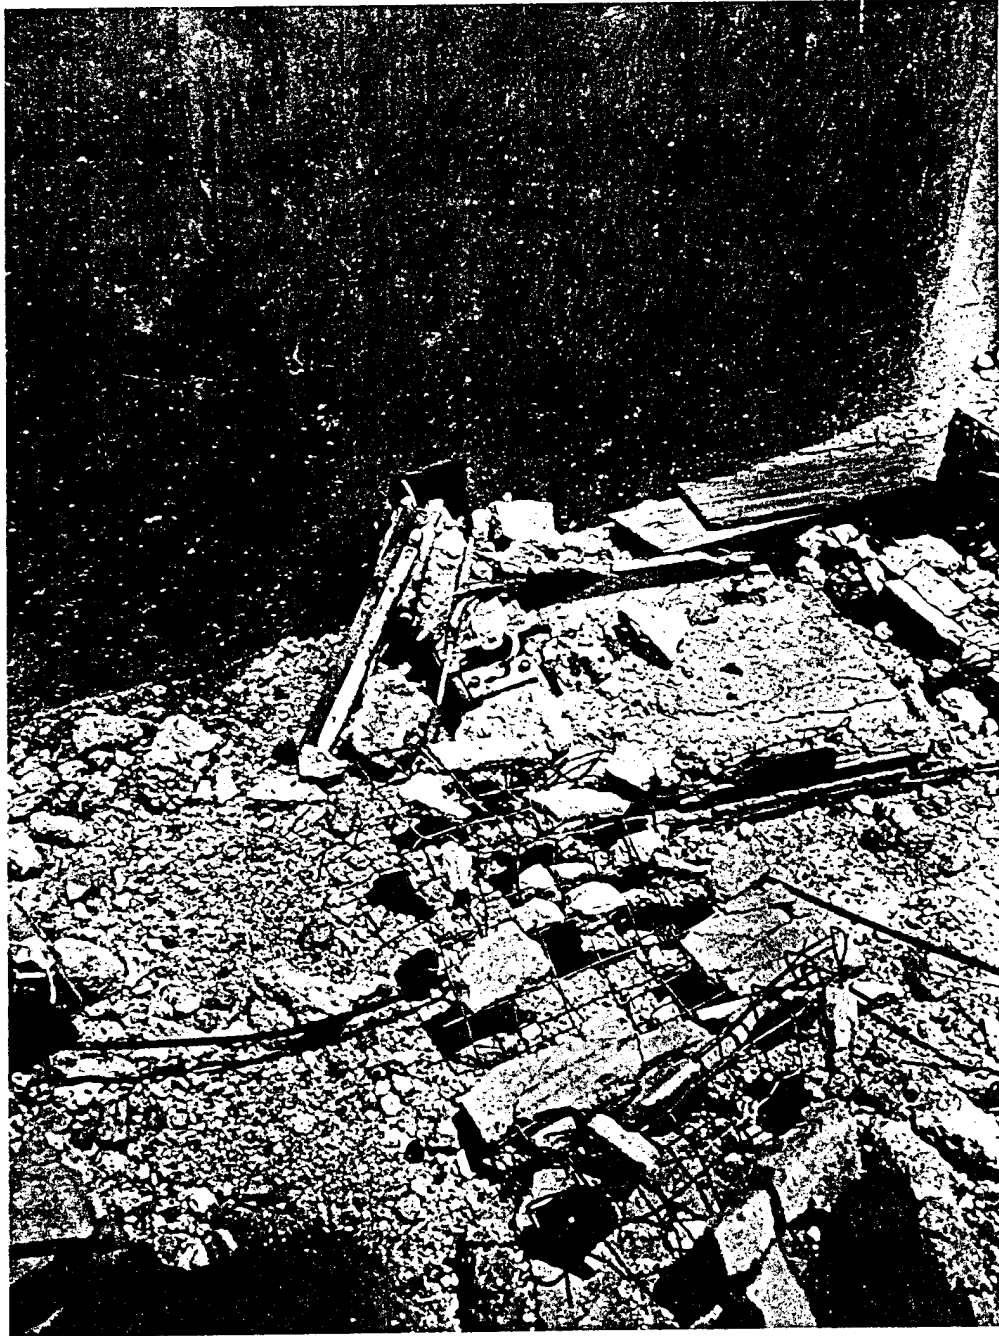
Fig. L.236 Detail View of Right-hand Panel of Rear Wall, Showing How Concrete Was Shattered When Struck by Portions of Front-wall Panels, Structure 3.2.3b

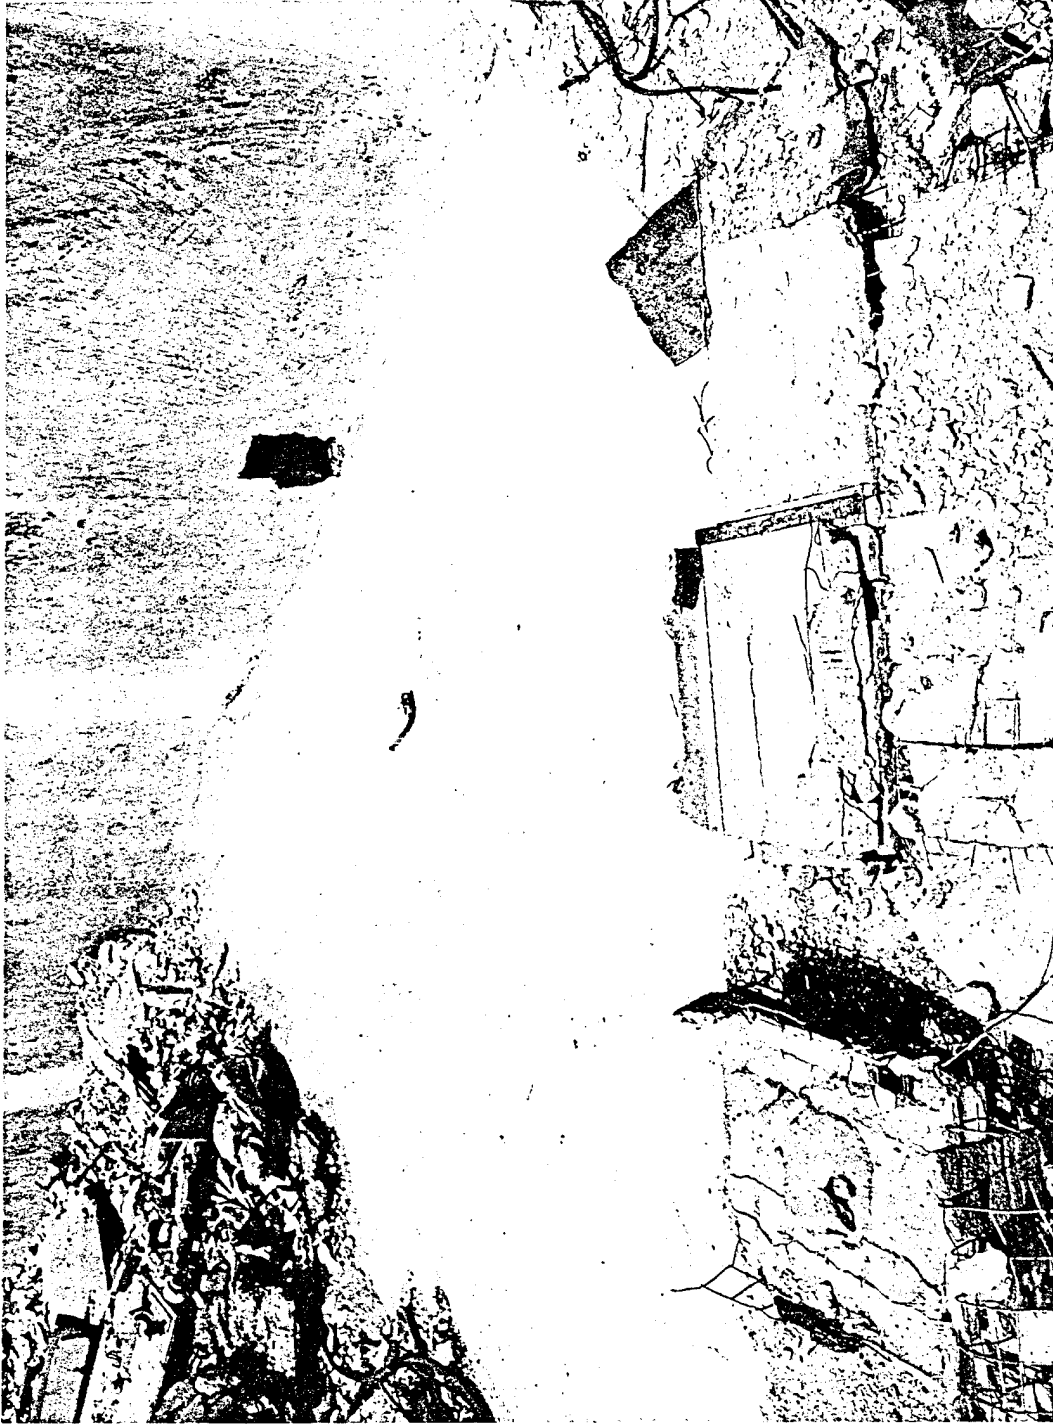
Fig. L.237 Detail View of Displacement Gauge Driven into Rear Wall, Structure 3.2.3b

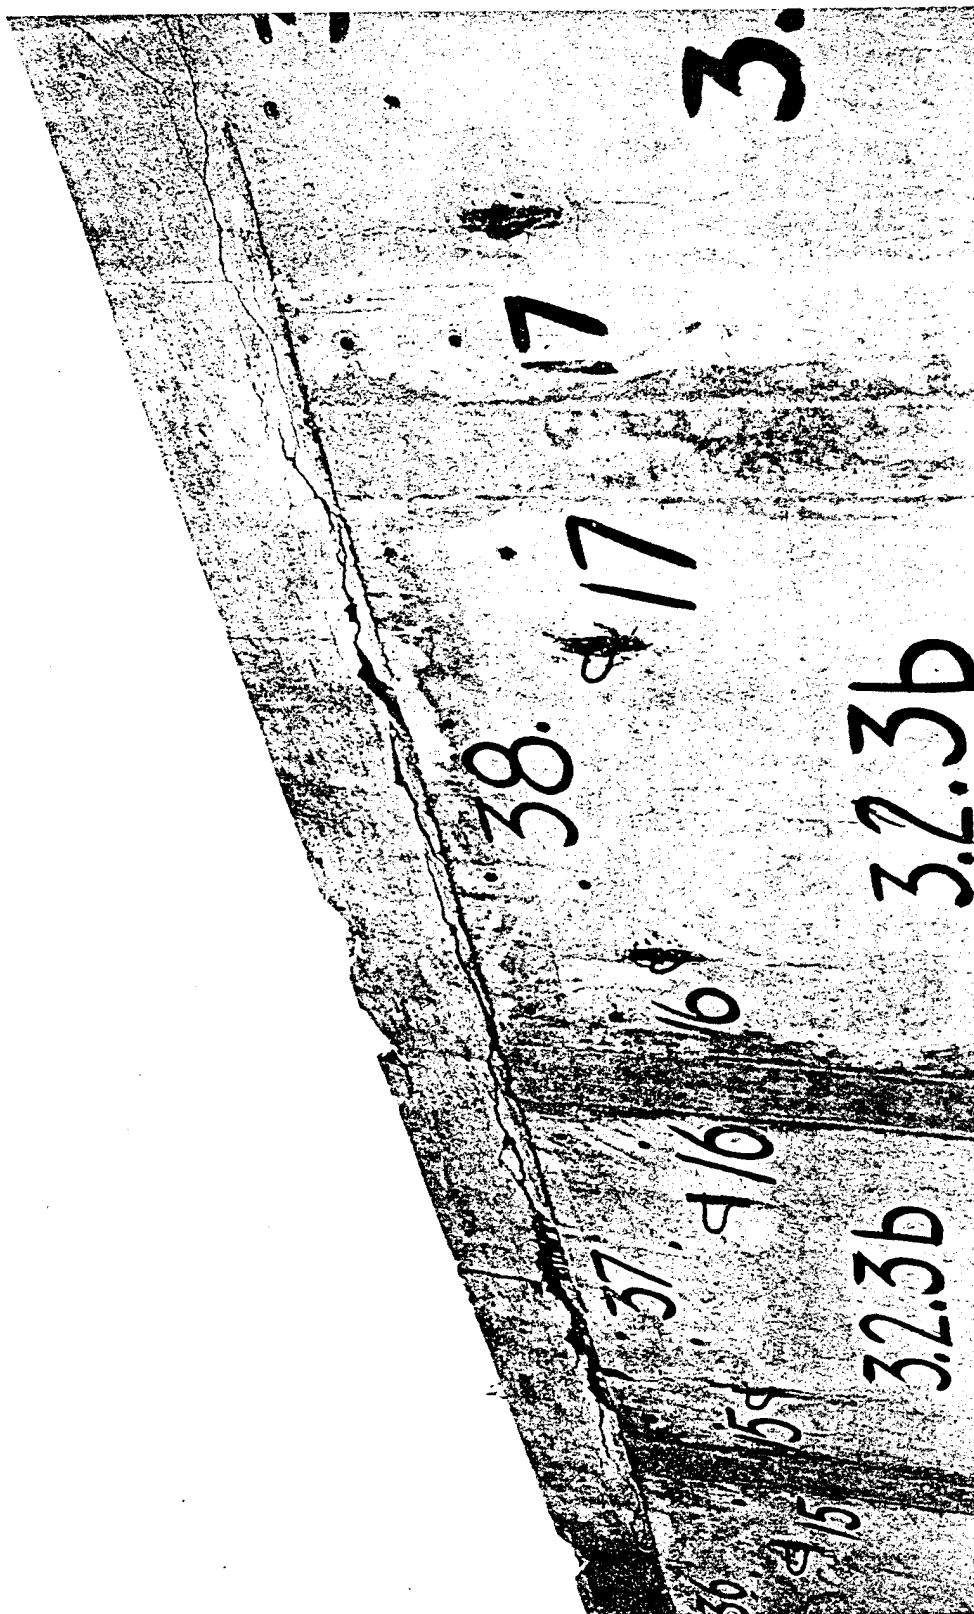
Fig. L.239 General View of Rear Wall, Taken from Rear, Structure 3.2.3b

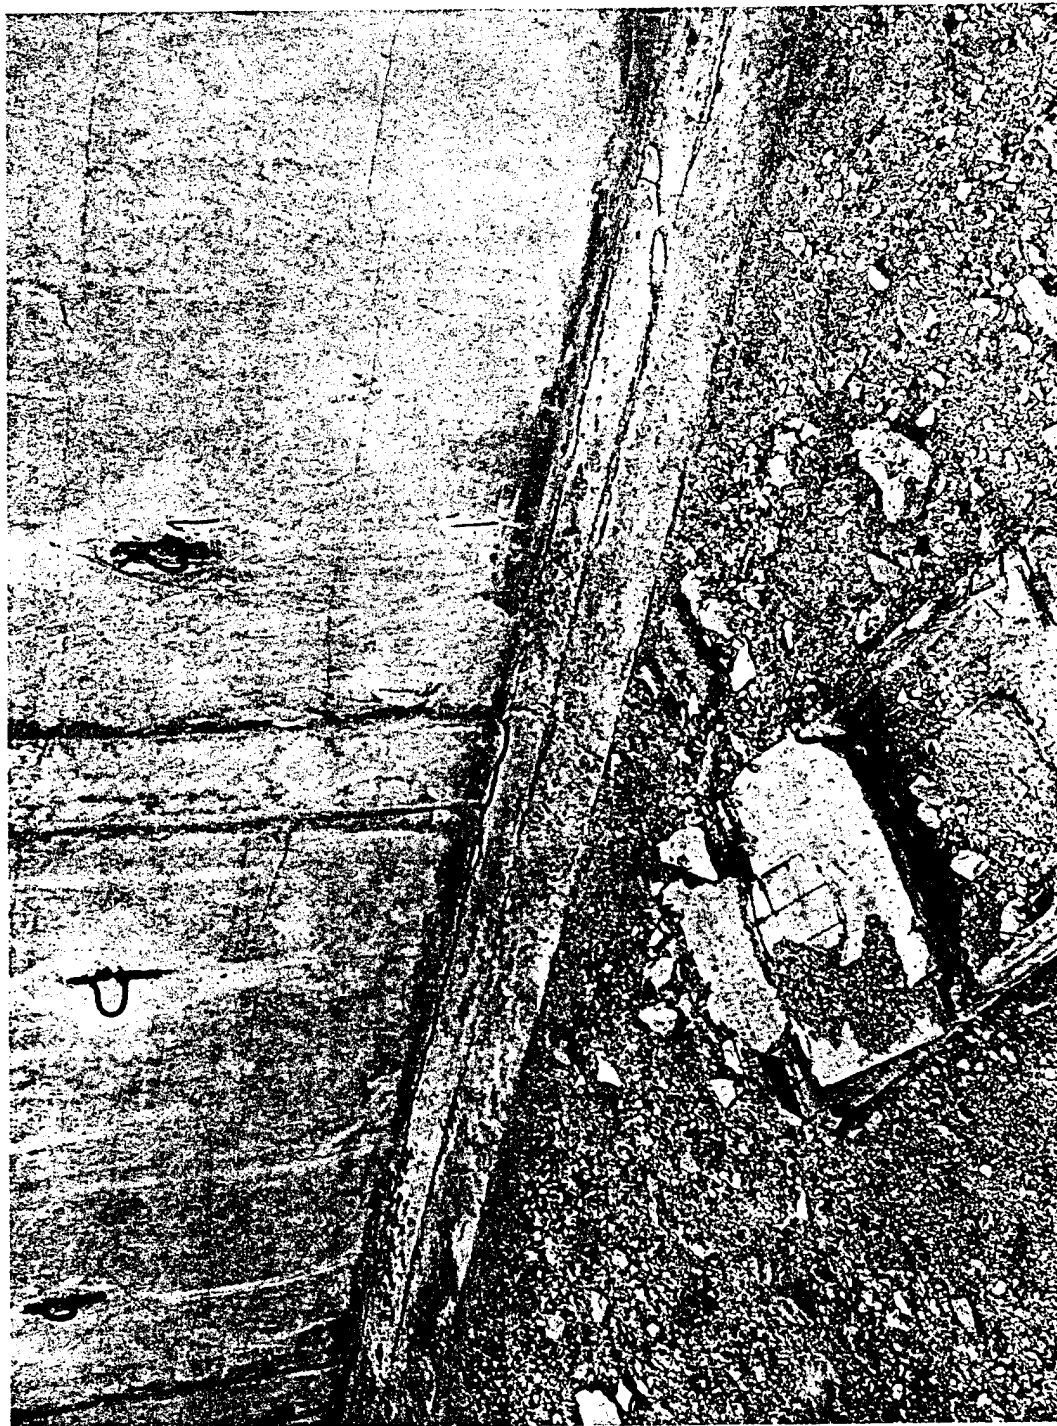
Fig. L.240 Upper Portion of Rear Wall in Center Section, Structure 3.2.3b
